COMPREHENSIVE FACILITIES STUDY  
OF THE  
EAST AND WEST HIGH SCHOOL BUILDINGS  
FOR THE

BOARD OF EDUCATION OF THE  
NORTHERN BURLINGTON COUNTY  
REGIONAL SCHOOL DISTRICT

## **EAST HIGH SCHOOL BUILDING**

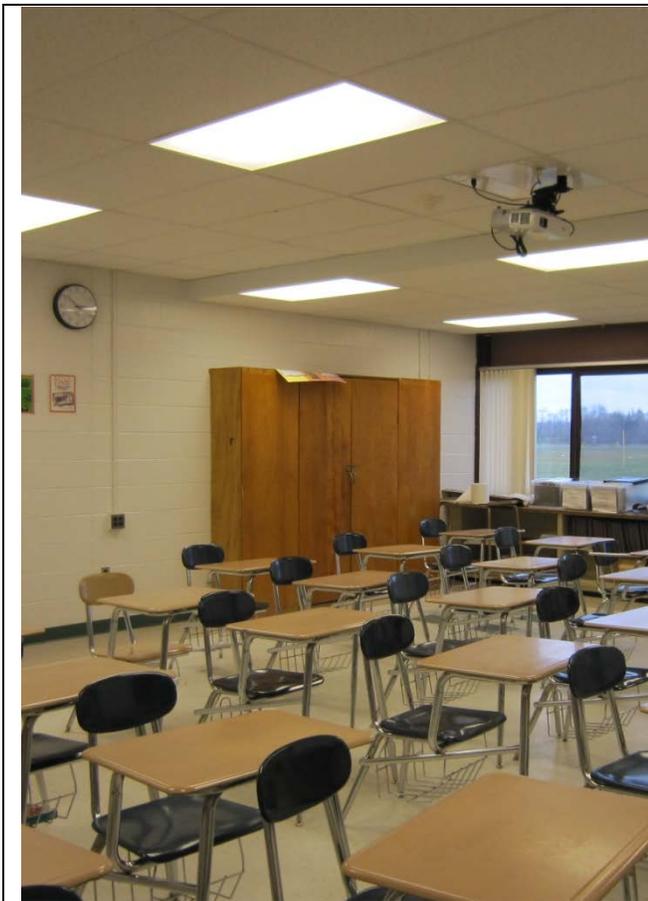
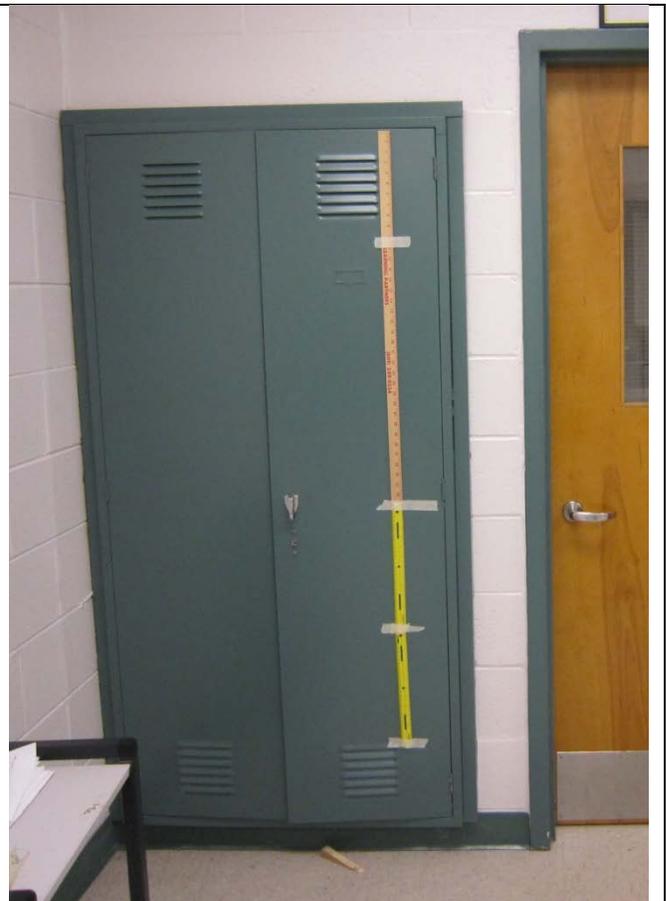
○ For your consideration, the following interior finishes are in need of replacement:

- Replace VAT Flooring due to being an asbestos laden material:
  - Storage 714 (151 sf)
  - Art Room 603 (1,265 sf)
    - **TOTAL = 1,416 sf @ \$5.00/sf = \$8,000**

- Replace Carpet Flooring that has extensive wear, rips and/or tearing:
  - Admin. Office 902 (563 sf)
  - Assistant Principal's Office A (182 sf)
  - Office B (104 sf)
  - Assistant Principal's Office C (120 sf)
  - Guidance Office 900 (361 sf)
  - Office 1 (96 sf)
  - Office 2 (91 sf)
  - Office 3 (91 sf)
  - Conference Room C (315 sf)
  - Storage 900 F (44 sf)
    - **TOTAL = 1,967 sf @ \$6.00/sf = \$12,000**

- Replace Metal Bookcases due to extensive wear, damage and functionality issues:
  - Classroom 700 (703 sf)
  - Classroom 702 (754 sf)
  - Classroom 703 (747 sf)
  - Classroom 705 (752 sf)
  - Classroom 707 (752 sf)
  - Classroom 709 (752 sf)
  - Classroom 711 (752 sf)
  - Classroom 713 (752 sf)
  - Classroom 715 (752 sf)
  - Classroom 717 (752 sf)
  - Classroom 719 (752 sf)
  - Classroom 721 (783 sf)
  - Classroom 712 (779 sf)
  - Classroom 716 (655 sf)
  - Classroom 718 (670 sf)
  - Classroom 607 (727 sf)

- Classroom 605 (724 sf)
  - Classroom 608 (1,163 sf)
  - Faculty Room 604 (576 sf)
    - **TOTAL = 19 Rooms @ \$3,000 ea. = \$57,000**
  - Replace Existing Gymnasium Partition due to age, wear and functionality issues:
    - **TOTAL = \$50,000**
  - Repair Existing Corridor Terrazzo Floor at areas of localized cracking:
    - 800 Hallway
      - **TOTAL = \$10,000**
- **INTERIOR SUBTOTAL = \$137,000**

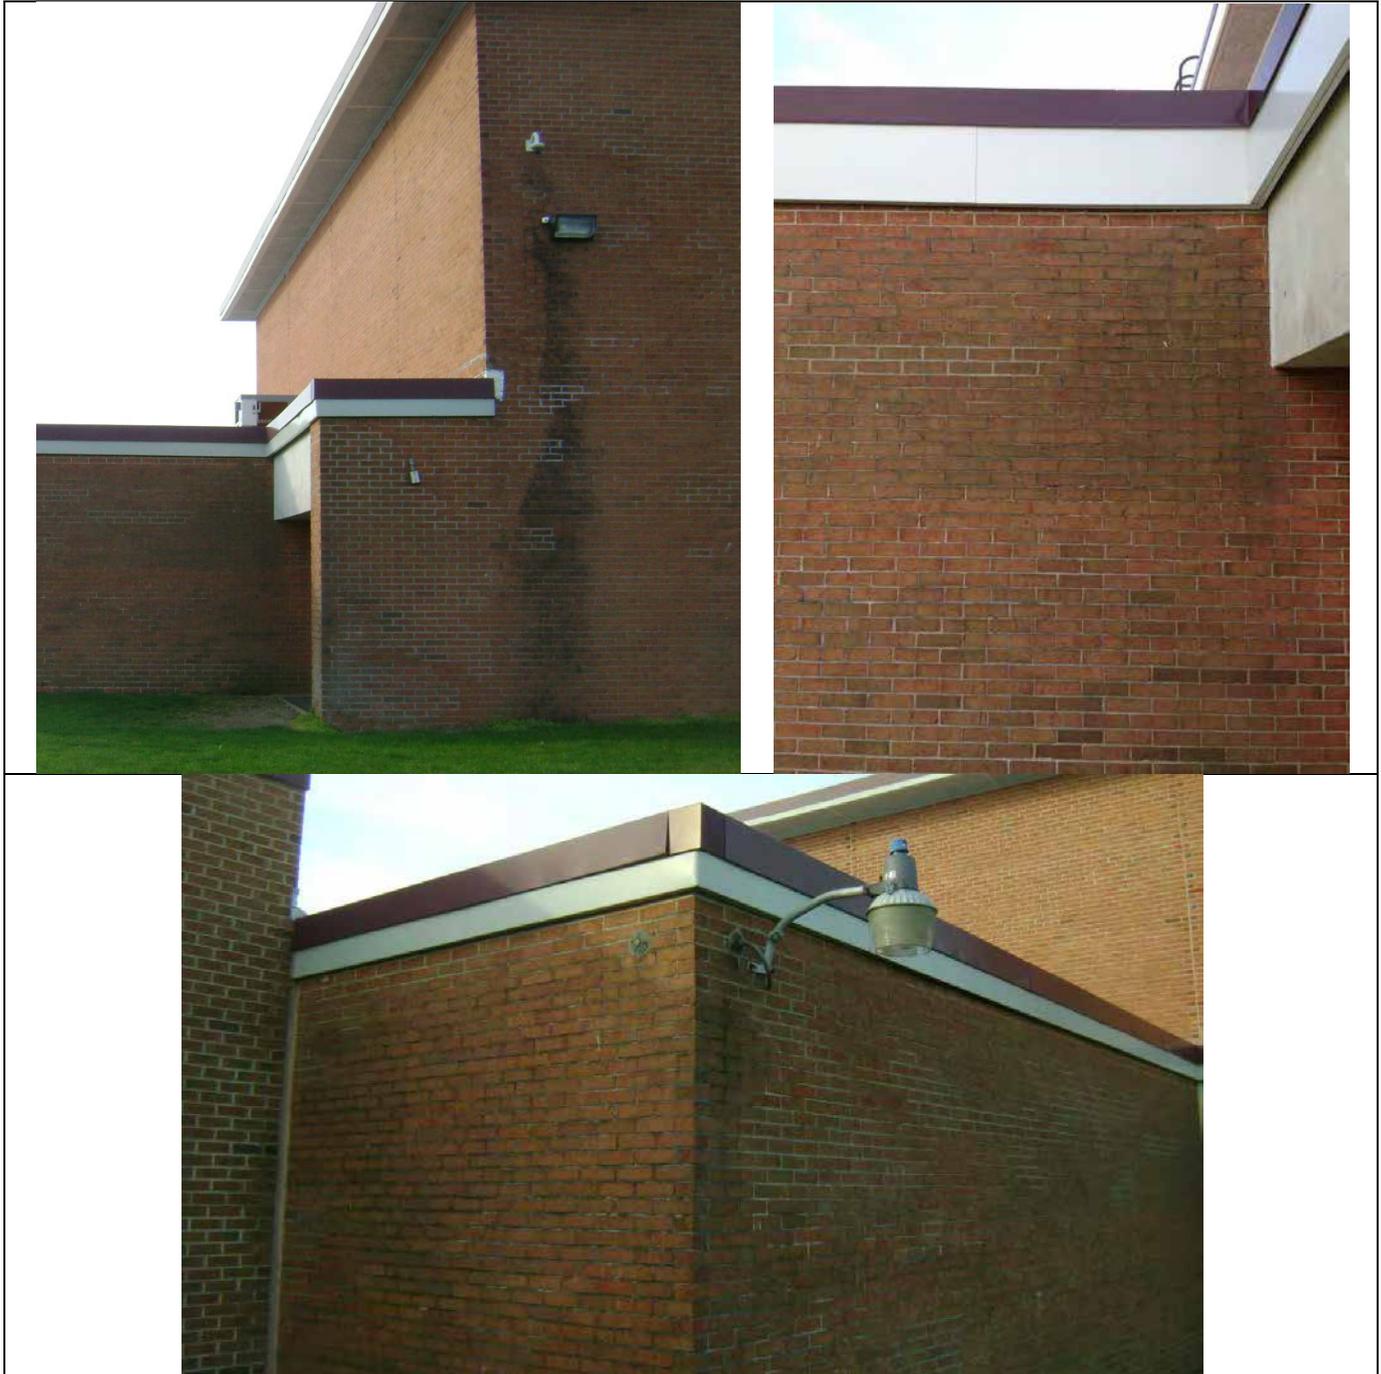
- **EXTERIOR CONDITIONS – BUILDING [CATEGORY B]**
  - For your consideration, the following exterior finishes are in need of replacement:
    - Exterior Masonry Restoration: **TOTAL = \$2,000**
  - **BUILDING SUBTOTAL = \$2,000**

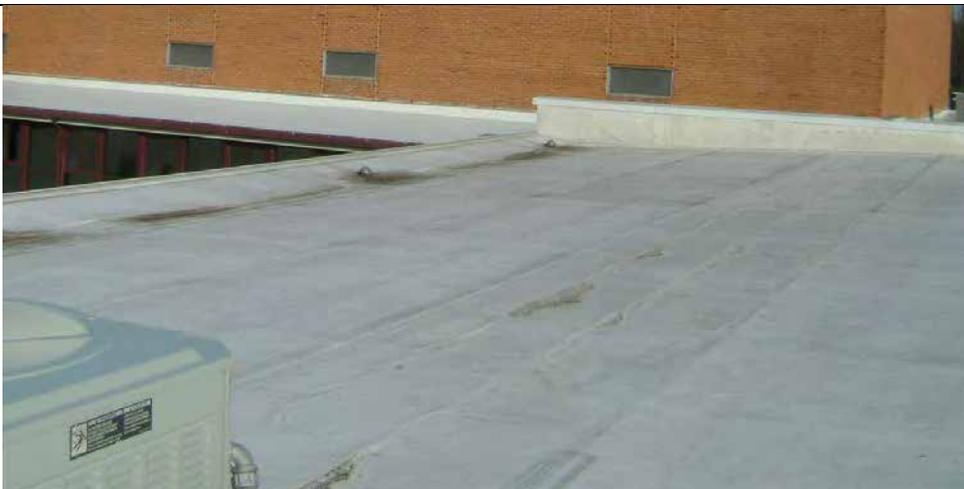
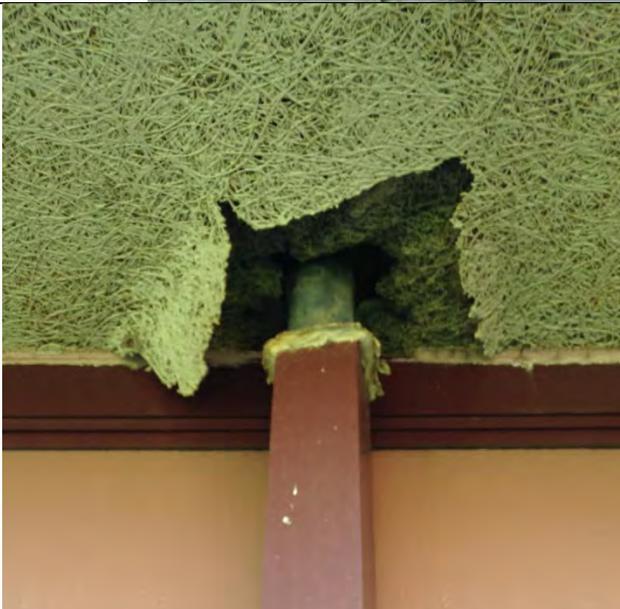
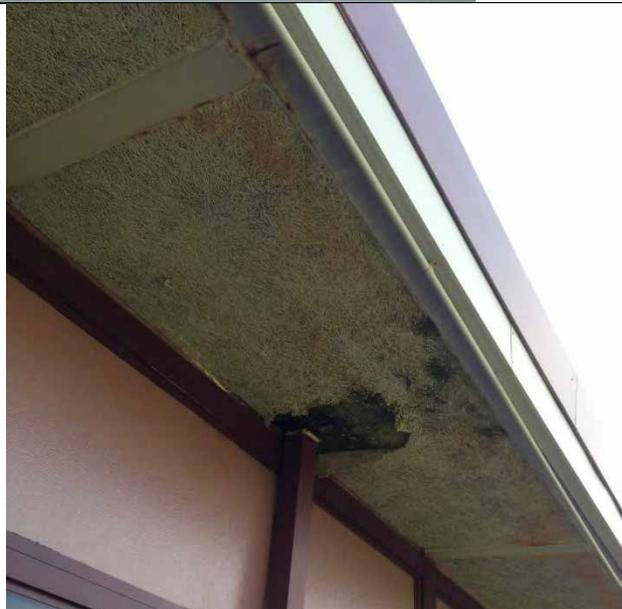
■ **EXTERIOR CONDITIONS – ROOF [CATEGORY B]**

- Total Roof Area = 79,322 ± square feet
- Roof Priorities are designated as:
  - **Priority 1 = 1993 and 1994 Roofs**
  - **Priority 2 = 1998 Roofs**
  - **Priority 3 = 2013 Roofs**
- The existing roofing and flashing systems are varied. Replacement is recommended on the 1993 and 1994 roofs due to age and imminent warranty expiration, at an estimated cost of:
  - **\$1,210,000**
- DEFICIENCIES:
  - **None**
- RECOMMENDATIONS:
  - Any leaks / problems to these roofs should be reported to the warranty issuer.
  - See Roof Key Plan for additional information.
- **ROOF SUBTOTAL = \$1,210,000**

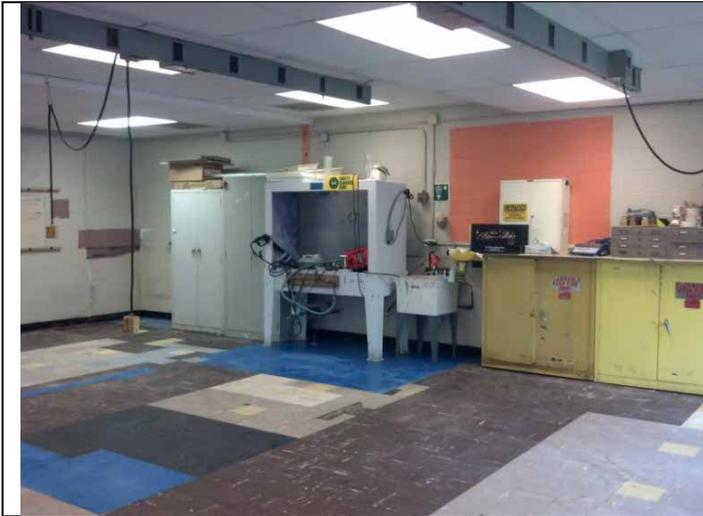
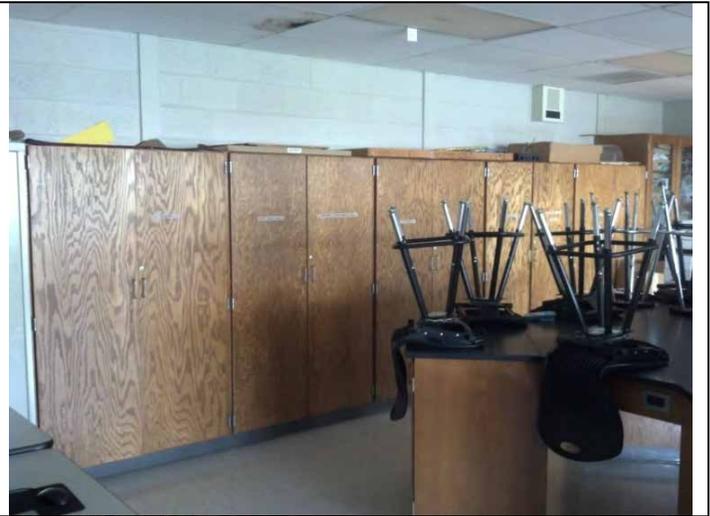
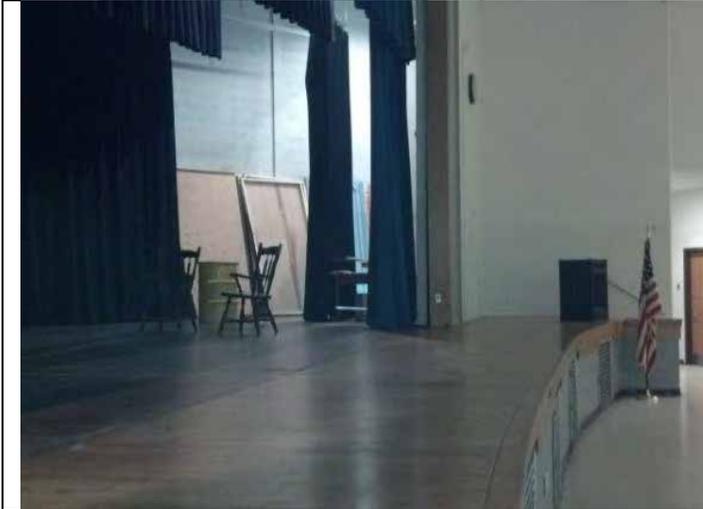
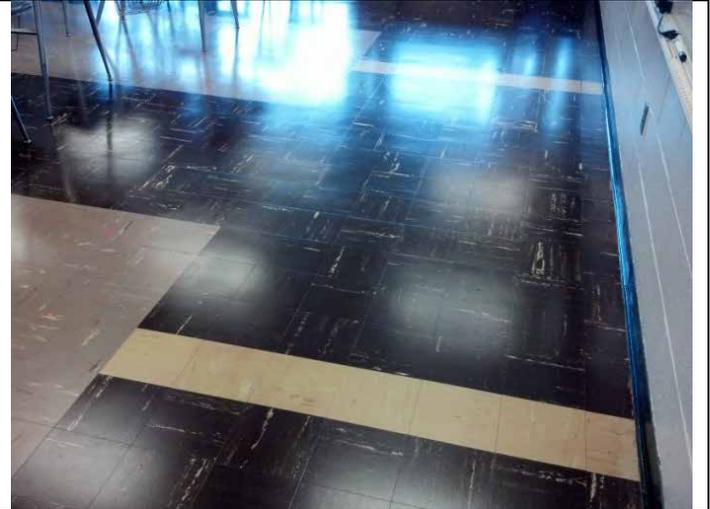
- Replace VCT Flooring that has extensive, cracking, cupping and/or patches:
  - Boys Locker Room Storage 1 (89 sf)
  - Boys Locker Room Storage 2 (80 sf)
  - Classroom 112 (804 sf)
  - Distance Education Classroom 306 (749 sf)
    - **TOTAL = 1,722 sf @ \$3.00/sf = \$5,200**

- Replace VAT Flooring due to being an asbestos laden material:
  - Prep Room 204A (193 sf)
  - Graphic Arts Room 104 (1,552 sf)
  - Computer Room 102 (965 sf)
  - Classroom 105 (949 sf)
  - Duplication/Publishing (756 sf)
  - Classroom 303 (721 sf)
    - **TOTAL = 5,136 sf @ \$5.00/sf = \$26,000**

- Overlay Existing Ceramic Tile Flooring that is uneven, cracked or has missing tiles:
  - Girls Toilet 400 (125 sf)
  - Men's Auditorium Toilet (268 sf)

- **TOTAL = 393 sf @ \$10.00/sf = \$4,000**
- Replace Acoustical Ceilings (Board & Grid) that is deteriorated, rusted and sagging:
  - Women's Faculty Toilet (50 sf)

- Weight Room 307/308 (1,391 sf)
  - Classroom 309 (690 sf)
  - Men's Auditorium Toilet (268 sf)
    - **TOTAL = 2,399 sf @ \$6.00/sf = \$15,000**
- Replace Acoustical Ceilings (Boards only) that have extensive sag and deterioration:

- Replace Stage Wood Flooring that has extensive wear:
  - Auditorium Stage 501 (2,264 sf)
    - **TOTAL = 2,264 sf @ \$15.00/sf = \$34,000**

- Repair Existing Corridor Terrazzo Floor at areas of localized cracking:
  - 100 Corridor (approx. 75 sf)
    - **TOTAL = approx. 75 sf = \$15,000**

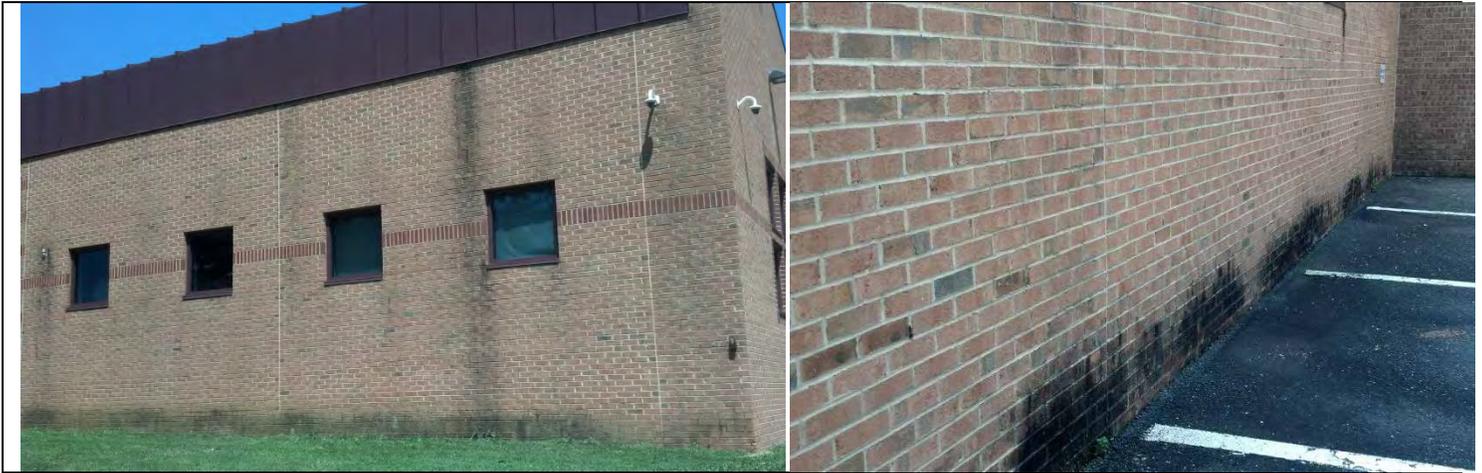
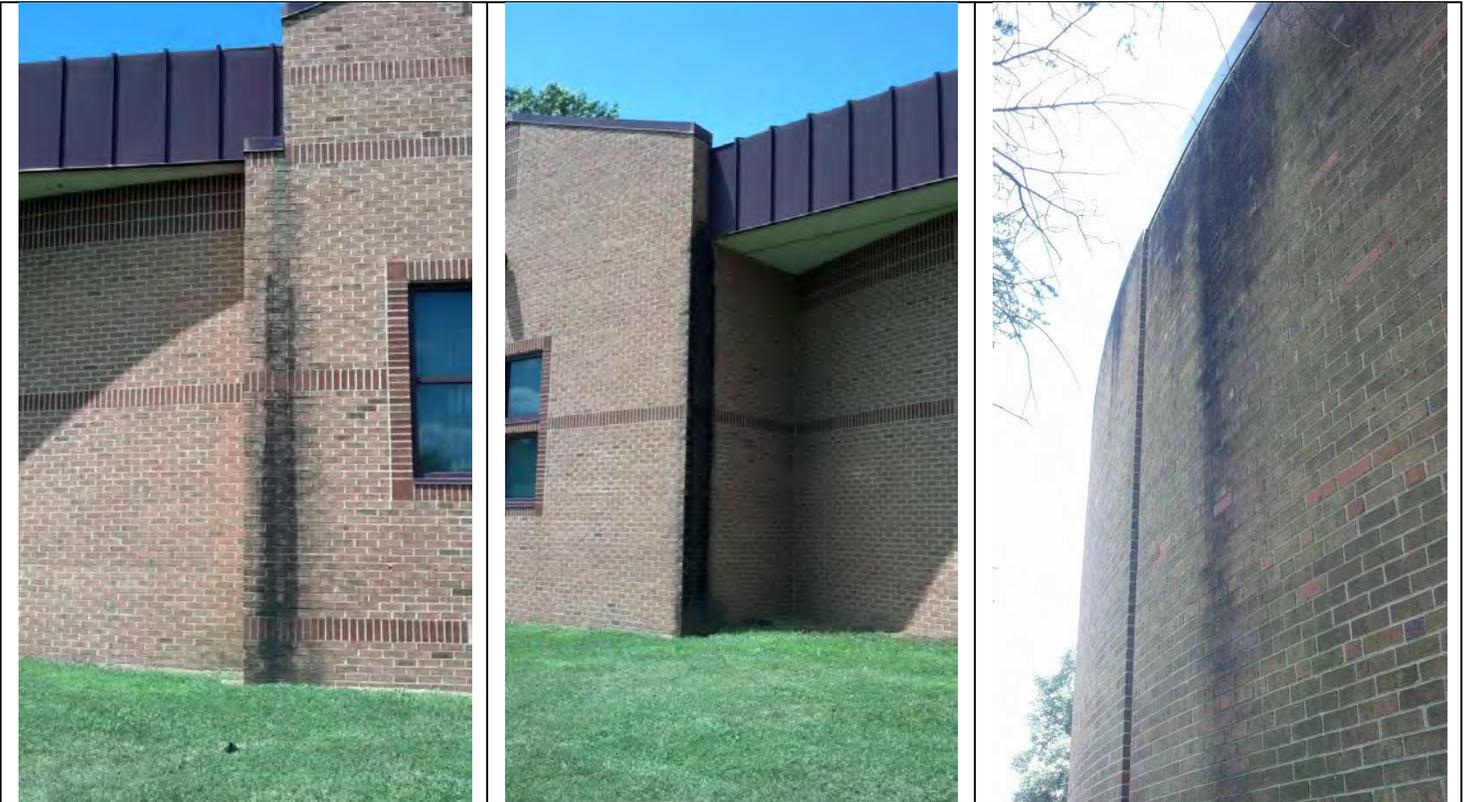
■ **EXTERIOR CONDITIONS – BUILDING [CATEGORY C,E]**

○ For your consideration, the following exterior finishes are in need of replacement:

• Exterior Masonry Restoration = **\$5,000**
