COMPREHENSIVE FACILITIES STUDY  
OF THE  
EAST AND WEST HIGH SCHOOL BUILDINGS  
FOR THE

BOARD OF EDUCATION OF THE  
NORTHERN BURLINGTON COUNTY  
REGIONAL SCHOOL DISTRICT

## **EAST HIGH SCHOOL BUILDING**

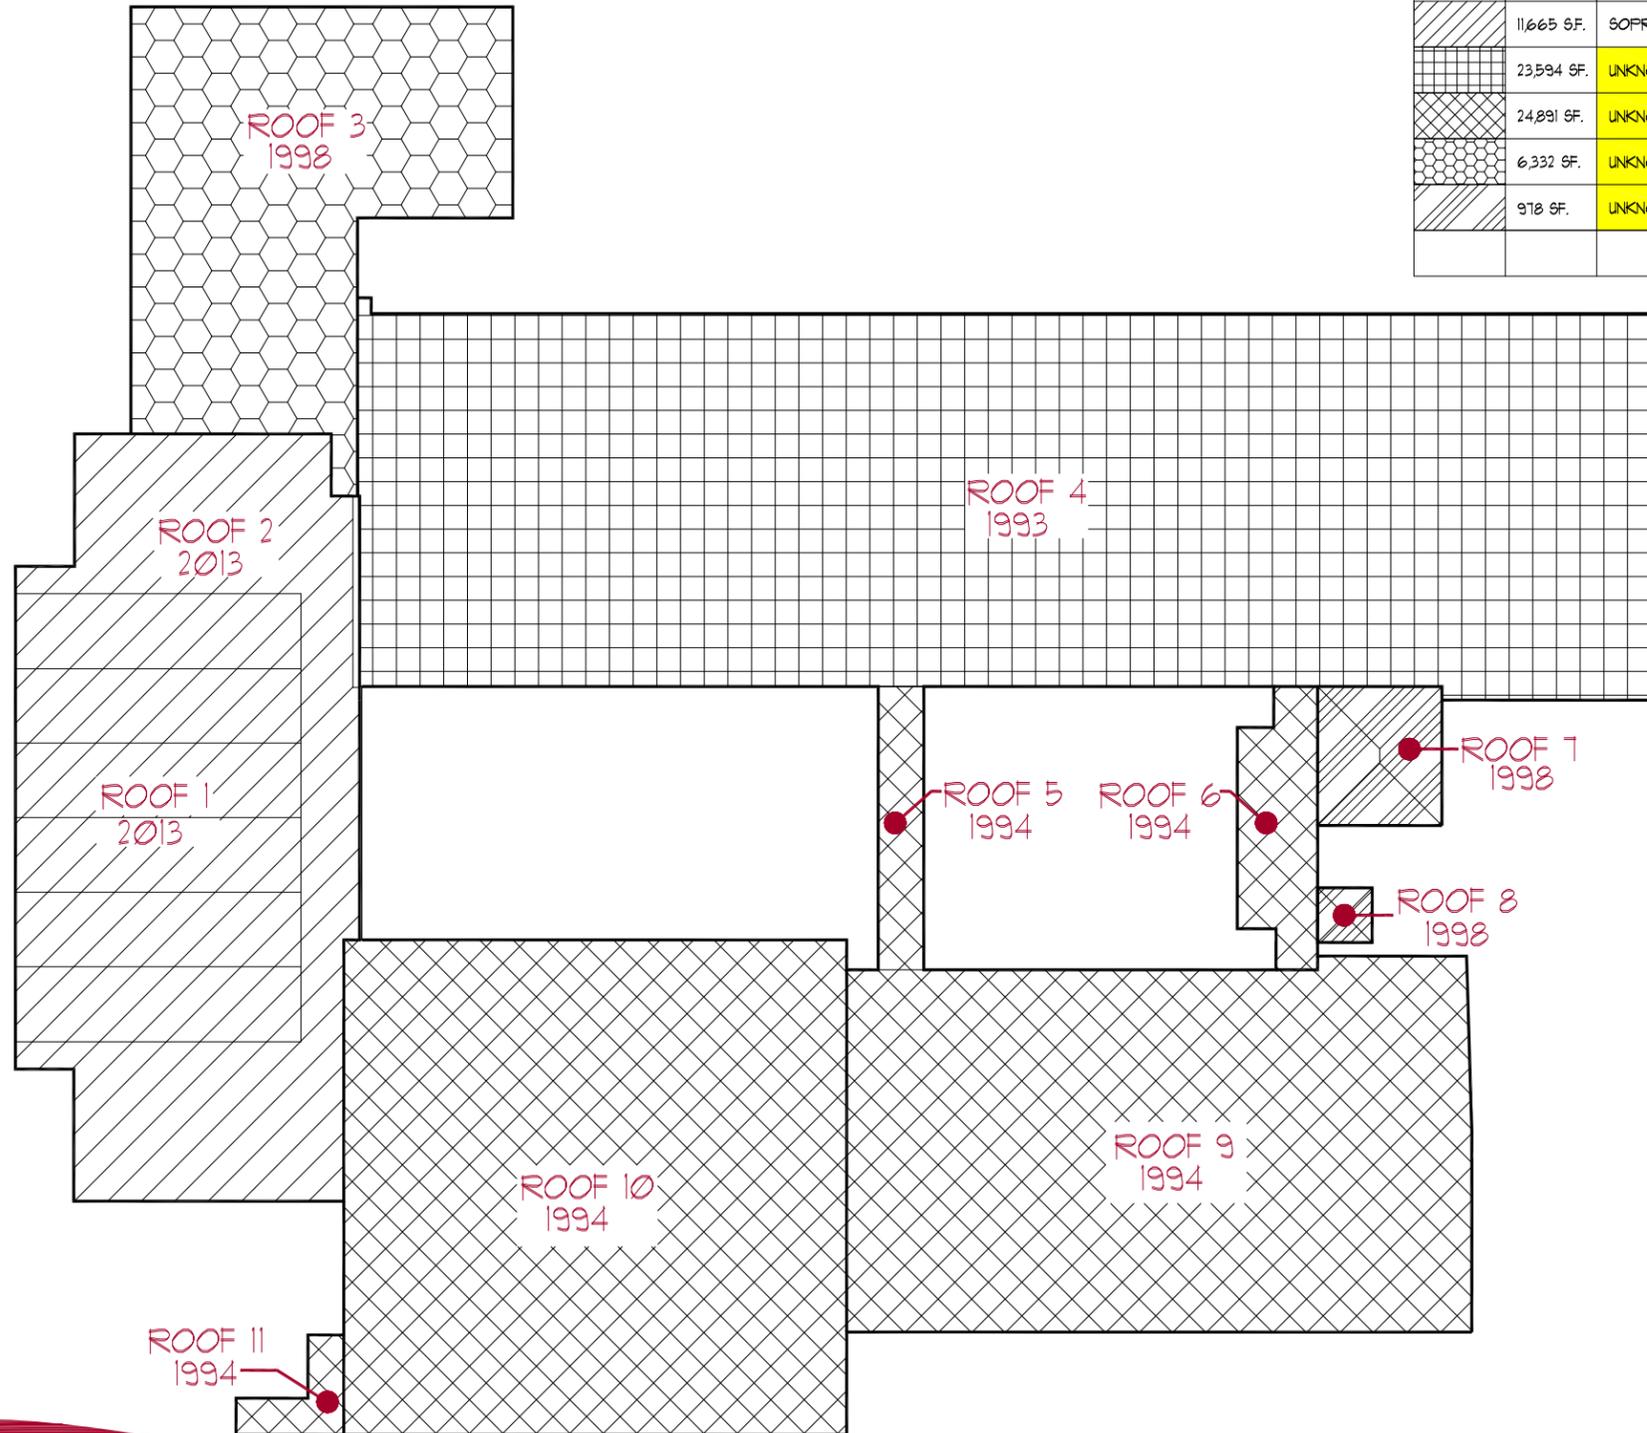
# HIGH SCHOOL EAST

AREA	MANUFACTURER	ROOFING SYSTEM	DATE INSTALLED	WARRANTY EXPIRATION	RECOMMENDED REPLACEMENT YEAR
	11,665 SF.	SOPREMA	SBS	2013	2033	2033
	23,594 SF.	UNKNOWN	TPO	1993	2008	2008
	24,891 SF.	UNKNOWN	TPO	1994	2009	2009
	6,332 SF.	UNKNOWN	TPO	1998	2018	2018
	978 SF.	UNKNOWN	S.S. METAL	1998

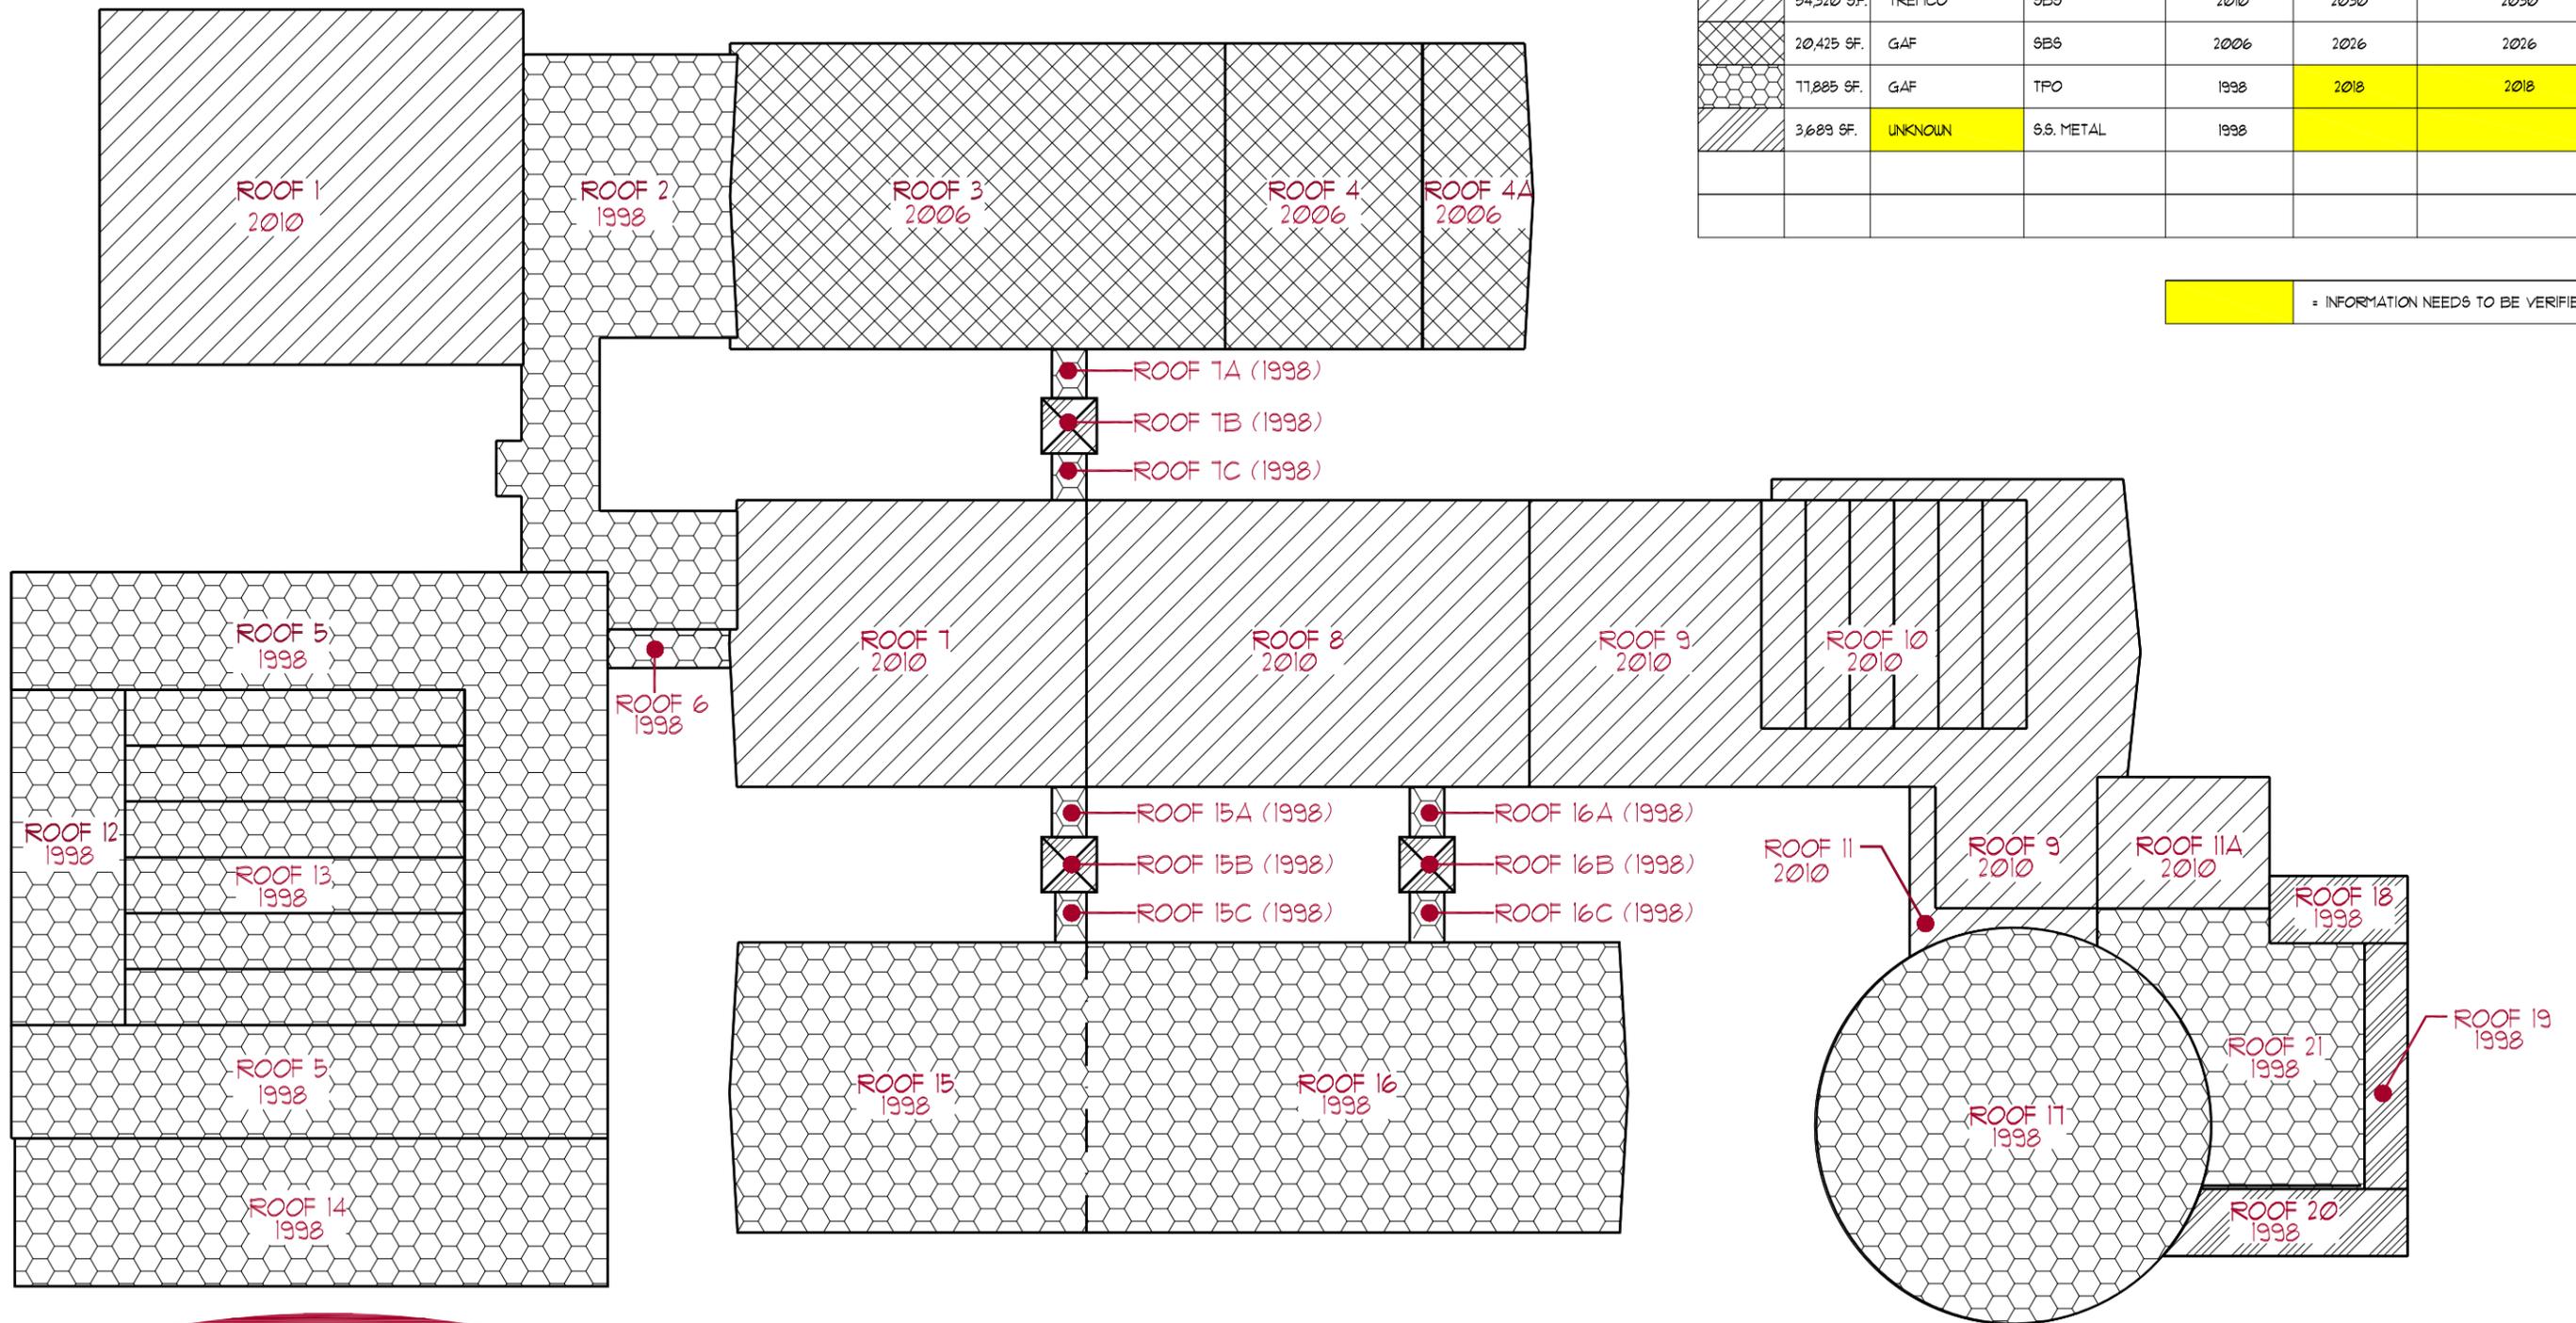
### ROOF HISTORY

HATCH	AREA	MANUFACTURER	ROOFING SYSTEM	DATE INSTALLED	WARRANTY EXPIRATION	RECOMMENDED REPLACEMENT YEAR
	54,320 SF.	TREMCO	SBS	2010	2030	2030
	20,425 SF.	GAF	SBS	2006	2026	2026
	11,885 SF.	GAF	TPO	1998	2018	2018
	3,689 SF.	UNKNOWN	S.S. METAL	1998

2009 ROOF REPLACEMENT  
AND SOLAR PANEL INSTALLATION
